INVESTIGATING THE EFFECTS OF SOIL EROSION ON RESIDENTIAL HOUSING IN OGERE REMO, OGUN STATE, NIGERIA

Oladimeji Olusola OJO and Abimbola Adedayo OGUNSOLA

Urban and Regional Planning Department, Federal Polytechnic Ilaro, Ogun State, Nigeria oladimeji.ojo@federalpolyilaro.edu.ng +2348063409884

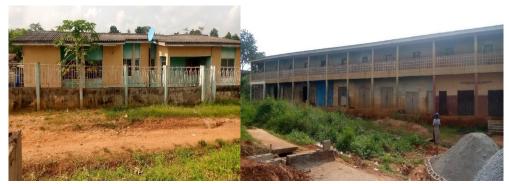
Plate 1: A compound building redesign with an eroded road

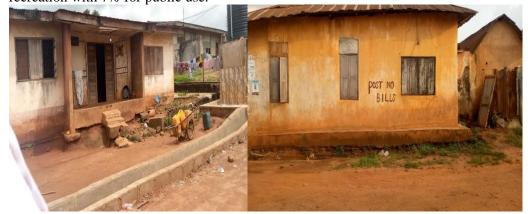
Plate 4: A residential building with an exposed foundation
